ENDURES- RPT24011

Comparative testing of antifouling coatings

Date	December 11, 2024
Author(s)	E. Abdullah, MSc and M. Salta, PhD
Number of pages	35 (incl. appendices)
Sponsor	SY Neutral Limited Attn. Mr. A. van Benthem 97 Windsor Street SLM 1853, Sliema Malta
Project name	Comparative testing of antifouling coatings
Project number	PROJ24011

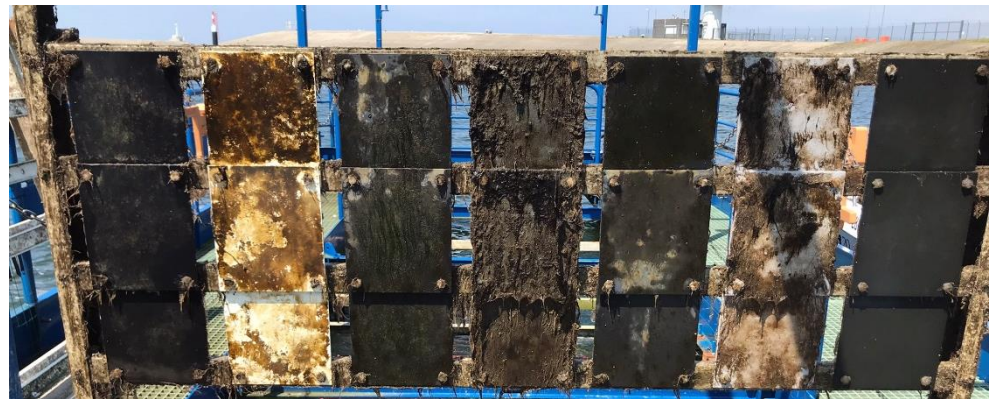
During the first visual inspection, 5 weeks after immersion (T1, Table 1), biofouling growth and coverage varied between and within coatings (Figure 4). All coatings displayed biofilm (aka slime) growth. Macrofouling taxa attached to the coatings included algae, tunicates, hydroids, and bryozoa (Figure 5). Along with a high coverage of hydroids, barnacles were present on the uncoated PVC panels.

Figure 4: Biofouling growth on coated panels after 5 weeks of exposure (T1) – from left to right: Hempablue, Nautix, Jotun, PVC (control), Trilux, Intersleek and Hempaguard. Three replicas of each coating are stacked vertically and denoted as A, B, and C from top to bottom.

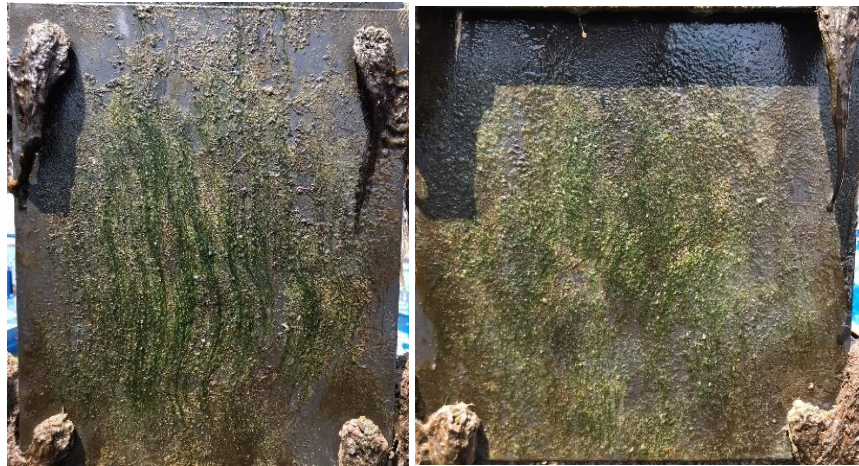
Hempablue, Nautix, and Hempaguard only had biofilm growth, with Hempaguard having the lowest coverage of biofilm. Jotun showed attachment of filamentous green algae (Figure 6). Trilux had growth of young tunicates on replica A and B. All three replicas also had macroalgae growth, however due to the size of the macroalgae it is considered as a part of the biofilm (in accordance with ECHA 2018). Intersleek was colonised by hydroids and some bryozoa. Biofouling coverage decreased with depth for certain coatings (Hempablue, Nautix, Trilux). All paints were able to prevent barnacle attachment, although their growth on the uncoated PVC panels did not indicate a high settlement pressure when compared to other taxa on T1.

Figure 6: Algae growth on Jotun A (left) and B (right) during the first inspection date (T1). Note that macroalgae coverage is calculated using only the initial attachment points.

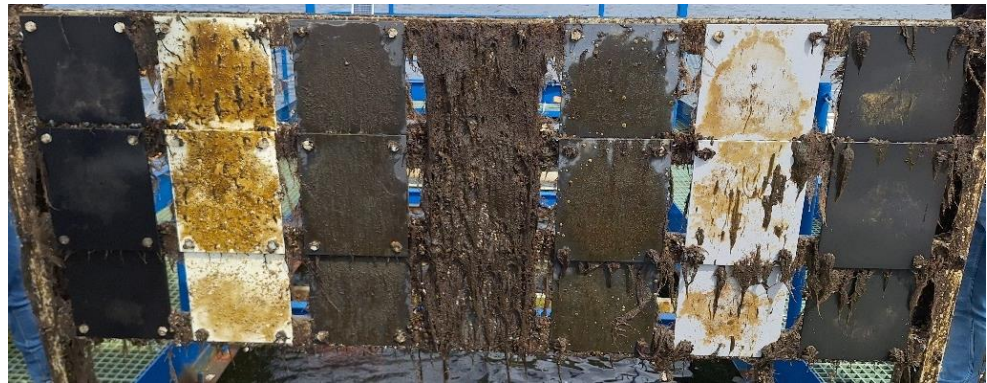
After 10 weeks of exposure (T2) (Figure 8,9), barnacles were able to settle on Nautix and Trilux (Figure 10, 11), however they were more prevalent on Nautix. Hempablue and Hempaguard were the only coatings without any macrofouling. In addition, Hempablue had a slightly lower biofilm coverage when compared to T1. Mussels started attaching to the PVC panels, indicating a settlement pressure from these taxa. However, they were not able to attach to any of the coated panels. Algal coverage only includes the attachment area, the increase in length is not reflected in the biofouling coverage. Intersleek coverage changed from mainly hydroids to mainly algae, and had a decrease in total biofouling coverage compared to T1.

Figure 8: Biofouling growth on coated panels after 10 weeks of exposure (T2) – from left to right: Hempablue, Nautix, Jotun, PVC (control), Trilux, Intersleek and Hempaguard. Three replicas of each coating are stacked vertically and denoted as A, B, and C from top to bottom.

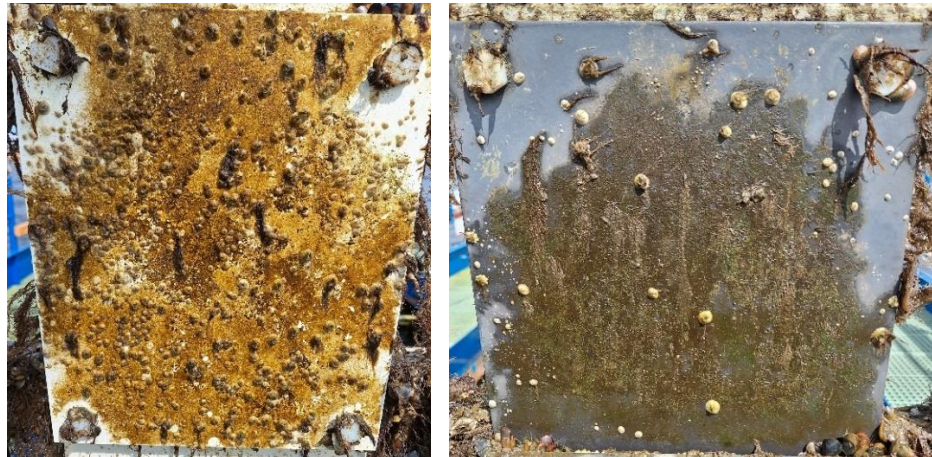
Figure 11: Left: Nautix B T2 with barnacle growth. Algae was attached to the barnacles but not to the panel. Right: Trilux A T2 with barnacle growth and hydroids.

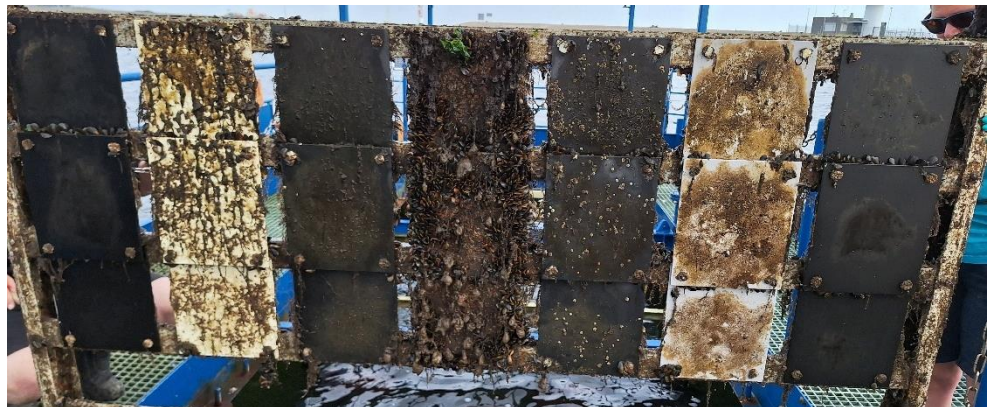
After 15 weeks of exposure (T3), the Hempablue panels had a moderate biofilm level, with the deepest replica (Hempablue C) having the least amount of biofilm (Figure 12, 13). Nautix still showed high levels of barnacle settlement, with slight attachment of tunicates, hydroids, and algae. Jotun displayed comparable biofouling coverage to T2, with some attachment of barnacles and tunicates. Tunicates were able to grow on Trilux as well. Taxa coverage and diversity was high for Intersleek, where bryozoa, barnacles, and tubeworms were able to attach, which were rarely seen on this coating during T1 and T2. Hempaguard had the lowest biofilm growth and no macrofouling taxa were attached on them. The PVC panels displayed growth of tunicates, barnacles, and mussels.

Figure 12: Biofouling growth on coated panels after 15 weeks of exposure (T3) – from left to right: Hempablue, Nautix, Jotun, PVC (control), Trilux, Intersleek and Hempaguard. Three replicas of each coating are stacked vertically and denoted as A, B, and C from top to bottom.

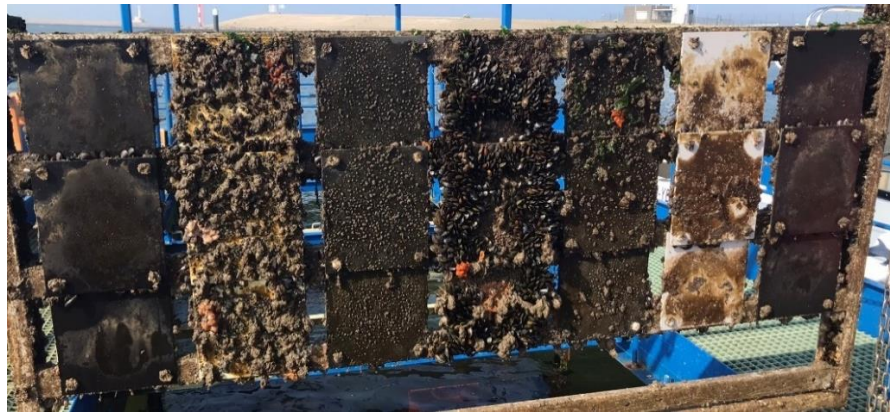
After 20 weeks of exposure (T4), Hempablue displayed slightly higher biofilm growth than previous dates but still showed resilience towards the attachment of macrofouling species (Figure 15, 16). All three Nautix panels were highly fouled with tunicates (Figure 17, 18). The barnacles seen in previous time points were likely covered by the tunicates, which made characterization of the barnacles difficult. While Jotun was covered with algae during T1 to T3, algae were absent from Jotun panels during T4. Jotun and Trilux, were covered with amphipods and their mud tubes. Since these motile species are rarely seen on ship hulls and are likely an artifact of static exposure experiments, they are not taken into account for the biofouling coverage (in accordance to ASTM D 6990 – 20 and ECHA, 2018). Barnacles were seen on Trilux beneath the mud tubes, and in small amounts on the PVC panels. Tunicates were seen on all Trilux and Intersleek replicas. Macrofouling coverage on Intersleek B was high, with growth of tunicates, bryozoa and tubeworms (Figure 18). Tubeworms were only seen on the Intersleek panels throughout the exposure period. Hempaguard displayed an increase in biofilm coverage compared to previous dates, especially in replica B. However, they still displayed the lowest growth on average and prevented macrofouling taxa from attaching. PVC panels displayed high levels of mussel growth, along with tunicates, hydroids and barnacles, although the barnacles were most likely dead. Since the dead barnacles when attached on a ship's hull can still have an effect on drag and are difficult to remove, they are still considered in the fouling evaluation.

Figure 15: Biofouling growth on coated panels after 20 weeks of exposure (T4) – from left to right: Hempablue, Nautix, Jotun, PVC (control), Trilux, Intersleek and Hempaguard. Three replicas of each coating are stacked vertically and denoted as A, B, and C from top to bottom.

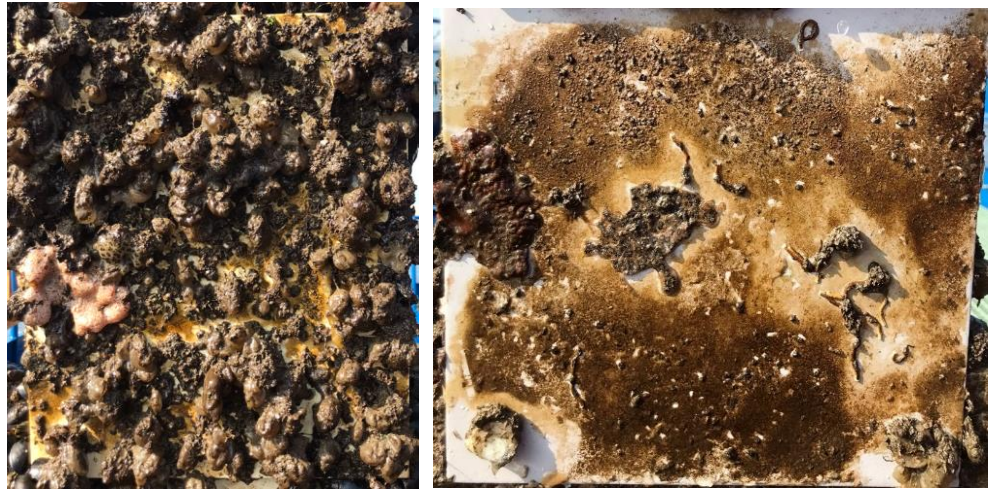
Figure 18: Closeups of macrofouling growth on panels during the T4 inspection. Solitary tunicate growth on Nautix B (left), Tubeworms and colonial tunicate growth on Intersleek C (right).

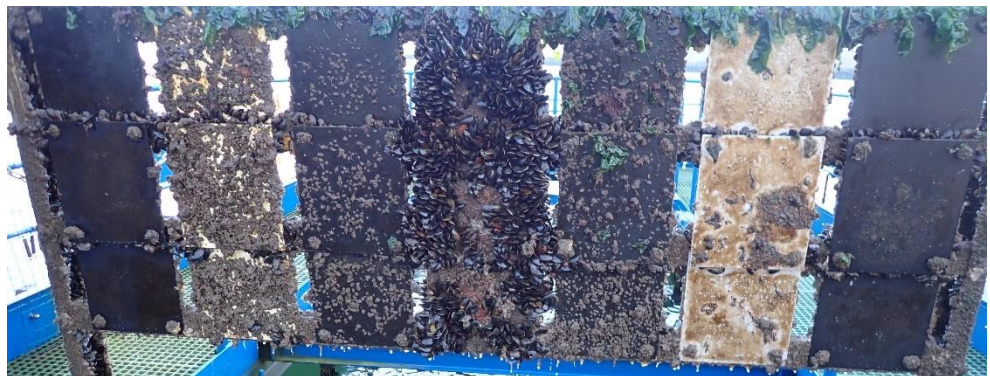
After 25 weeks of exposure (T5), Hempablue maintained moderate levels of biofilm without any growth of macrofouling species (Figure 19, 20). Tunicate pressure had decreased on the Nautix panels and was instead replaced by amphipod mud tubes. The mud tubes were often present on or around barnacles, using their sturdy makeup as a foundation. Mud tubes were also present on Jotun and Trilux panels. While the mud tubes were surrounding barnacles on the Trilux panels, the Jotun panels were free of barnacles, resulting in a less sturdy attachment of the mud tubes directly on the coating. Aside from the mud tubes, the Jotun panels were only covered by biofilm with levels lower than previous dates for replicas B and C. The Trilux panels had barnacles attached to the coating, with secondary structures (mud tubes, green and red seaweed) growing over them. Intersleek panel B had high growth of bryozoa, along with several tubeworms. The bryozoa were absent on the Intersleek A replica. Hempaguard still displayed low levels of biofilm growth, however juvenile barnacles were found attached to the coating. While still in low numbers and size, this does indicate a potential for barnacles to attach to this coating after extended periods of idleness.

Figure 19: Biofouling growth on coated panels after 25 weeks of exposure (T5) – from left to right: Hempablue, Nautix, Jotun, PVC (control), Trilux, Intersleek and Hempaguard. Three replicas of each coating are stacked vertically and denoted as A, B, and C from top to bottom.

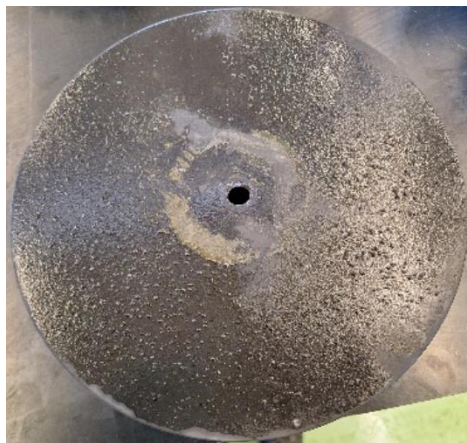
Figure 28: Algae attached to Jotun (R2) after the first FDM run after 12 weeks of raft exposure

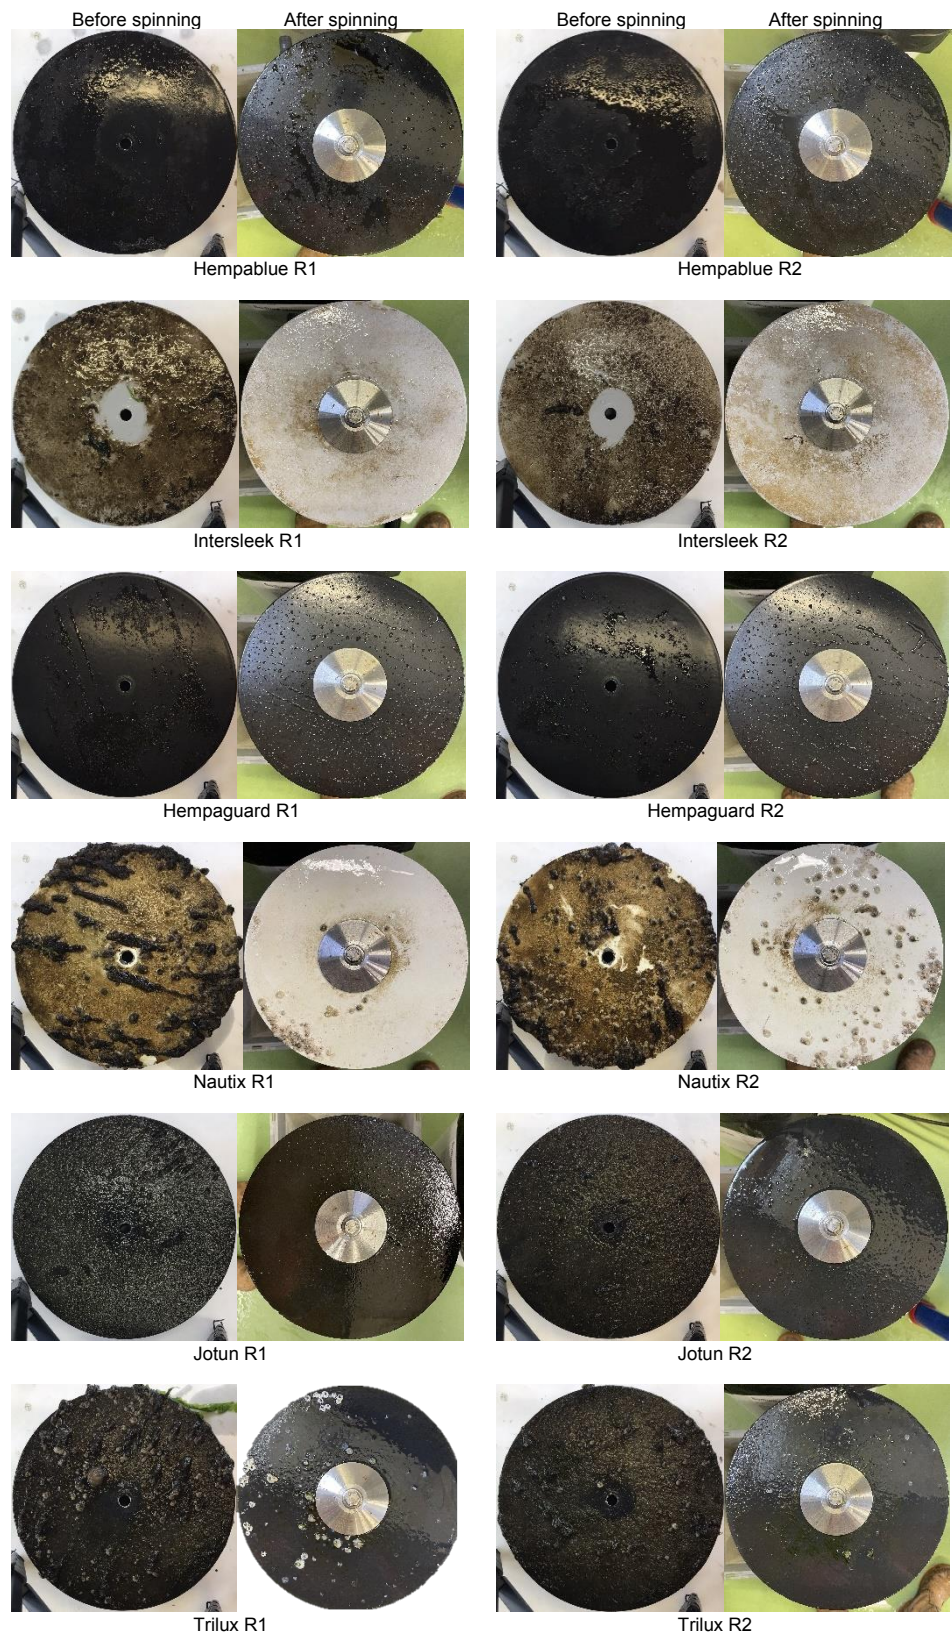
Plate 1: Discs that were exposed on the raft for 12 weeks, before and after spinning on the FDM for the first run.
