ENDURES- RPT24011

Comparative testing of antifouling coatings

Date	December 11, 2024
Author(s)	E. Abdullah, MSc and M. Salta, PhD
Number of pages	35 (incl. appendices)
Sponsor	SY Neutral Limited Attn. Mr. A. van Benthem 97 Windsor Street SLM 1853, Sliema Malta
Project name	Comparative testing of antifouling coatings
Project number	PROJ24011

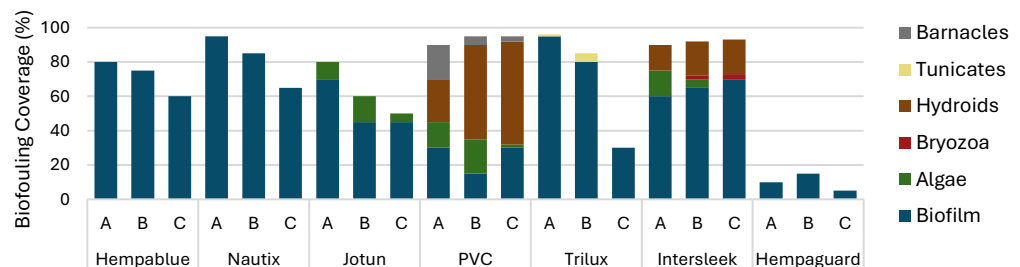
During the first visual inspection, 5 weeks after immersion (T1, Table 1), biofouling growth and coverage varied between and within coatings (Figure 4). All coatings displayed biofilm (aka slime) growth. Macrofouling taxa attached to the coatings included algae, tunicates, hydroids, and bryozoa (Figure 5). Along with a high coverage of hydroids, barnacles were present on the uncoated PVC panels.

Figure 5: Biofouling coverage (%) during T1 per replica of each coated panel and the uncoated PVC panels. The edges of the panels are not included in the assessment of biofouling coverage. A, B, C stands for different replicas.

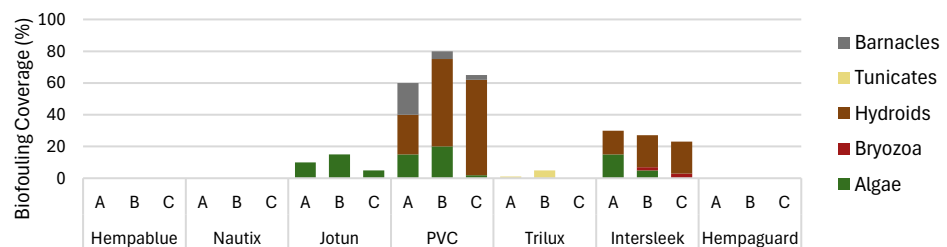
When calculating fouling rating for the efficacy test according to the ASTM 6990 D – 20 standard, biofilm coverage plays a minimal role. Therefore, a separate graph without biofilm coverage is displayed (Figure 7). Biofouling coverage, when not taking biofilm into account, shows that Intersleek had moderate levels of macrofouling. Hydroids and bryozoa were seen on Intersleek which were not seen on any of the other coated panels.

Figure 7: Macrofouling coverage (%) during T1 per replica of each coated panel and the uncoated PVC panels. Does not include biofilm. The edges of the panels are not included in the assessment of biofouling coverage. A, B, C stands for different replicas.

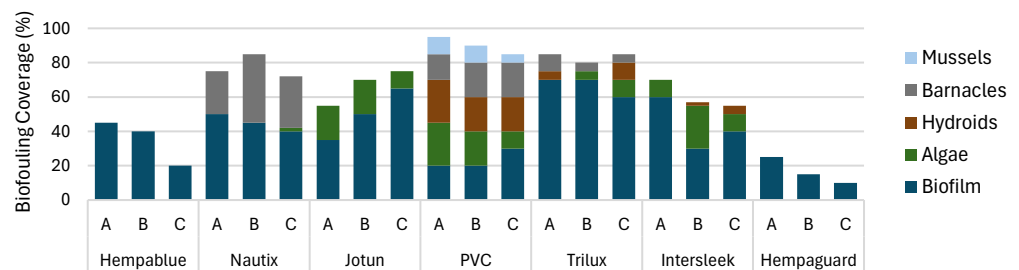
After 10 weeks of exposure (T2) (Figure 8,9), barnacles were able to settle on Nautix and Trilux (Figure 10, 11), however they were more prevalent on Nautix. Hempablue and Hempaguard were the only coatings without any macrofouling. In addition, Hempablue had a slightly lower biofilm coverage when compared to T1. Mussels started attaching to the PVC panels, indicating a settlement pressure from these taxa. However, they were not able to attach to any of the coated panels. Algal coverage only includes the attachment area, the increase in length is not reflected in the biofouling coverage. Intersleek coverage changed from mainly hydroids to mainly algae, and had a decrease in total biofouling coverage compared to T1.

Figure 9: Biofouling coverage (%) during T2 per replica of each coated panel and the uncoated PVC panels. The edges of the panels are not included in the assessment of biofouling coverage. A, B, C stands for different replicas.

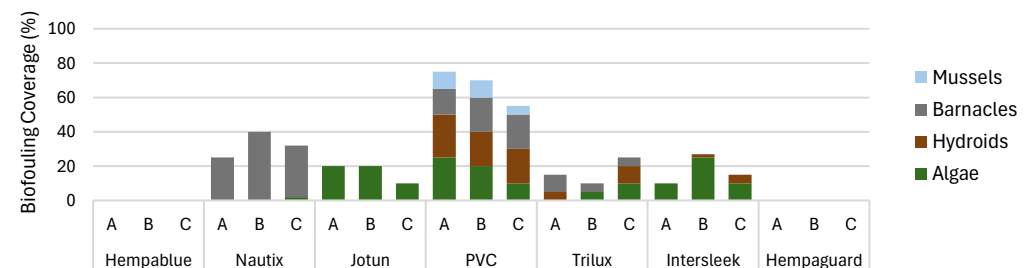
When looking at the coverage of macrofouling taxa (Figure 10), Nautix had the highest coverage, consisting predominantly of barnacles. Jotun, Trilux and Intersleek had a relatively low fouling coverage consisting of mainly algae for Jotun and Intersleek, and barnacles for Trilux.

Figure 10: Macrofouling coverage (%) during T2 per replica of each coated panel and the uncoated PVC panels. Does not include biofilm. The edges of the panels are not included in the assessment of biofouling coverage. A, B, C stands for different replicas.

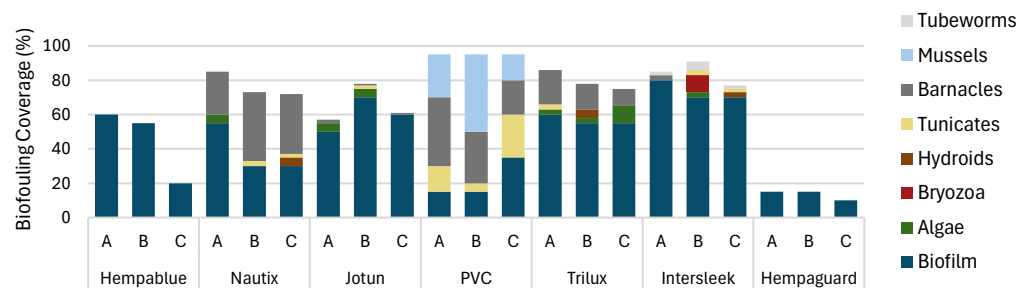
After 15 weeks of exposure (T3), the Hempablue panels had a moderate biofilm level, with the deepest replica (Hempablue C) having the least amount of biofilm (Figure 12, 13). Nautix still showed high levels of barnacle settlement, with slight attachment of tunicates, hydroids, and algae. Jotun displayed comparable biofouling coverage to T2, with some attachment of barnacles and tunicates. Tunicates were able to grow on Trilux as well. Taxa coverage and diversity was high for Intersleek, where bryozoa, barnacles, and tubeworms were able to attach, which were rarely seen on this coating during T1 and T2. Hempaguard had the lowest biofilm growth and no macrofouling taxa were attached on them. The PVC panels displayed growth of tunicates, barnacles, and mussels.

Figure 13: Biofouling coverage (%) during T3 per replica of each coated panel and the uncoated PVC panels. The edges of the panels are not included in the assessment of biofouling coverage. A, B, C stands for different replicas.

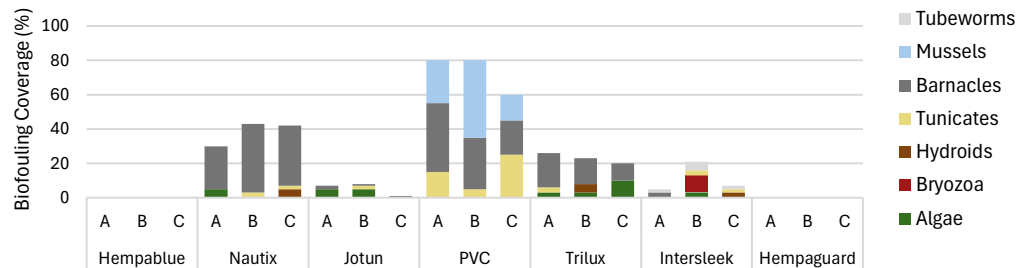
Assessment of macrofouling surface area coverage (Figure 14) showed that Nautix and Trilux had a relatively high coverage of barnacles, comparable to the level of growth on the PVC panels. Macrofouling growth on the Jotun panels was relatively low, and lower than previous inspections. Intersleek had lower macrofouling growth than Nautix and Trilux but had calcareous species which were not seen on the other coatings (tubeworms and bryozoa).

Figure 14: Macrofouling coverage (%) during T3 per replica of each coated panel and the uncoated PVC panels. Does not include biofilm. The edges of the panels are not included in the assessment of biofouling coverage. A, B, C stands for different replicas.

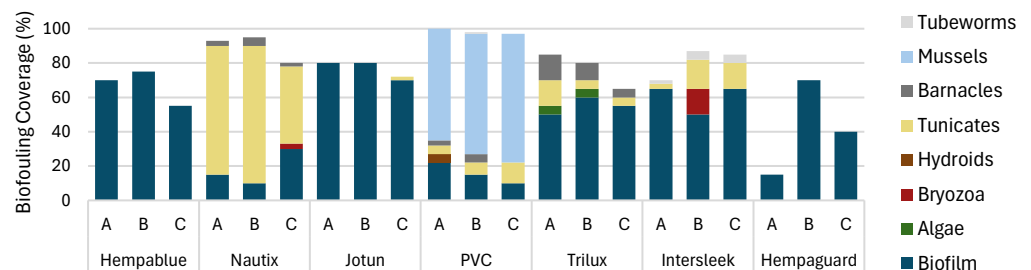
After 20 weeks of exposure (T4), Hempablue displayed slightly higher biofilm growth than previous dates but still showed resilience towards the attachment of macrofouling species (Figure 15, 16). All three Nautix panels were highly fouled with tunicates (Figure 17, 18). The barnacles seen in previous time points were likely covered by the tunicates, which made characterization of the barnacles difficult. While Jotun was covered with algae during T1 to T3, algae were absent from Jotun panels during T4. Jotun and Trilux, were covered with amphipods and their mud tubes. Since these motile species are rarely seen on ship hulls and are likely an artifact of static exposure experiments, they are not taken into account for the biofouling coverage (in accordance to ASTM D 6990 – 20 and ECHA, 2018). Barnacles were seen on Trilux beneath the mud tubes, and in small amounts on the PVC panels. Tunicates were seen on all Trilux and Intersleek replicas. Macrofouling coverage on Intersleek B was high, with growth of tunicates, bryozoa and tubeworms (Figure 18). Tubeworms were only seen on the Intersleek panels throughout the exposure period. Hempaguard displayed an increase in biofilm coverage compared to previous dates, especially in replica B. However, they still displayed the lowest growth on average and prevented macrofouling taxa from attaching. PVC panels displayed high levels of mussel growth, along with tunicates, hydroids and barnacles, although the barnacles were most likely dead. Since the dead barnacles when attached on a ship's hull can still have an effect on drag and are difficult to remove, they are still considered in the fouling evaluation.

Figure 16: Biofouling coverage (%) during T4 per replica of each coated panel and the uncoated PVC panels. The edges of the panels are not included in the assessment of biofouling coverage. A, B, C stands for different replicas.

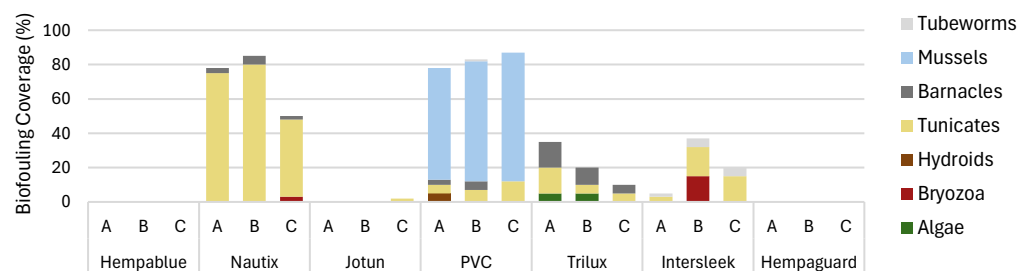
Nautix had a macrofouling coverage up to 85% (Figure 17). Intersleek B and C had slight increases in macrofouling growth compared to T3. Barnacle coverage on the Trilux coatings decreased slightly compared to T4, but this may have been due to the difficulty of assessing barnacle growth which was covered by other species and amphipod mud tubes.

Figure 17: Macrofouling coverage (%) during T4 per replica of each coated panel and the uncoated PVC panels. Does not include biofilm. The edges of the panels are not included in the assessment of biofouling coverage. A, B, C stands for different replicas.

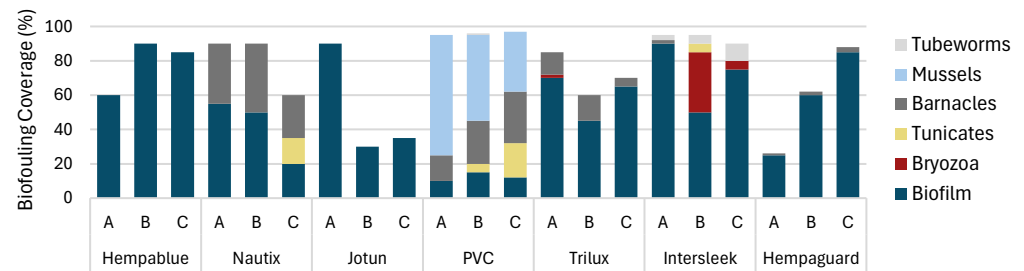
After 25 weeks of exposure (T5), Hempablue maintained moderate levels of biofilm without any growth of macrofouling species (Figure 19, 20). Tunicate pressure had decreased on the Nautix panels and was instead replaced by amphipod mud tubes. The mud tubes were often present on or around barnacles, using their sturdy makeup as a foundation. Mud tubes were also present on Jotun and Trilux panels. While the mud tubes were surrounding barnacles on the Trilux panels, the Jotun panels were free of barnacles, resulting in a less sturdy attachment of the mud tubes directly on the coating. Aside from the mud tubes, the Jotun panels were only covered by biofilm with levels lower than previous dates for replicas B and C. The Trilux panels had barnacles attached to the coating, with secondary structures (mud tubes, green and red seaweed) growing over them. Intersleek panel B had high growth of bryozoa, along with several tubeworms. The bryozoa were absent on the Intersleek A replica. Hempaguard still displayed low levels of biofilm growth, however juvenile barnacles were found attached to the coating. While still in low numbers and size, this does indicate a potential for barnacles to attach to this coating after extended periods of idleness.

Figure 20: Biofouling coverage (%) during T5 per replica of each coated panel and the uncoated PVC panels. The edges of the panels are not included in the assessment of biofouling coverage. A, B, C stands for different replicas.

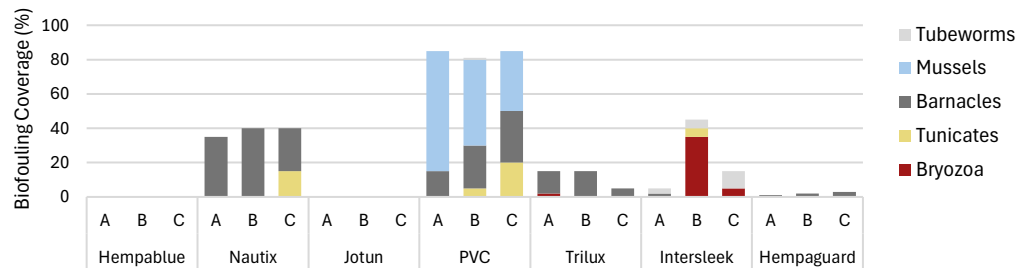
When assessing macrofouling coverage (Figure 21), Nautix displayed a lowered macrofouling coverage compared to T4, mainly due to the decrease in tunicates. Intersleek B had a large increase in bryozoa attachment.

Figure 21: Macrofouling coverage (%) during T5 per replica of each coated panel and the uncoated PVC panels. Does not include biofilm. The edges of the panels are not included in the assessment of biofouling coverage. A, B, C stands for different replicas.

Throughout the 25-week raft exposure period, the Hempablue coating displayed exceptional fouling control capabilities. No macrofouling species were observed on any of the replicas, even at the end of the raft exposure period (Figure 21). Biofilm coverage varied over time and grew thicker at the last inspection date. However, macrofouling organisms were still being prevented from growing on top of this biofilm layer, indicating a high capacity for the prevention of macrofouling growth.

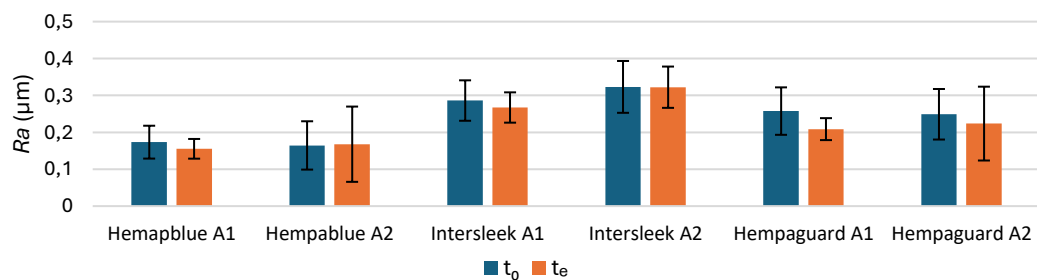
Average surface roughness (R_a) of the different coatings was measured before (t_0) and after (t_e) aging coated discs for 10 weeks (Figure 22, Figure 23). R_a values were consistently lower for FRC (0,15 μm - 0,32 μm) compared to SPC coatings (0,85 μm - 1,65 μm).

R_a did not change considerably after aging for all the FRCs. Hempablue had the lowest average R_a (0,17 – 0,15 average R_a before and after aging respectively across both replicas) while Intersleek A2 had the highest average out of the FRCs (0,32 μm before and after).

Figure 22: Roughness values (R_a) of FRCs before (t_0) and after (t_e) aging. Error bars indicate the standard deviation within each replica (N=36). A1 = Aging Replica 1, A2 = Aging Replica 2

Surface roughness of the coating did not change after aging nor after exposure on the raft, which is similar across the FRCs (Figures 22 and 29). The surface roughness of the Hempablue coating was the lowest out of all coatings but was relatively close to that of the other FRCs. The thickness of the coating did not change during aging nor raft exposure (Figures 24 and 31). As an FRC, the thickness of the coating is not expected to change since there is no ablation or self-polishing mechanic necessary (Yebra et al., 2004).

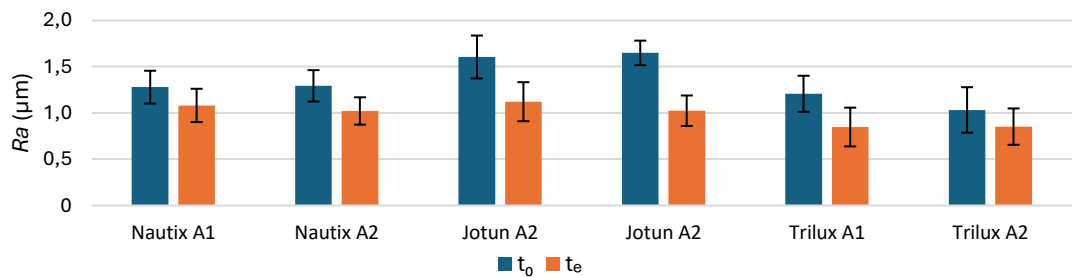
For the SPC coatings (Figure 23), average R_a values were consistently lower after aging for each coating (average of 1,34 μm and 0,99 μm at t_0 and t_e respectively), however the averages were still within the standard deviation of each other except for Jotun A2, which had the largest effect of aging on surface roughness. Jotun had the highest surface roughness. Trilux and Nautix had comparable surface roughness values before aging, however Trilux discs had a lower roughness following the aging treatment compared to Nautix.

Figure 23: Roughness values (R_a) of SPC coatings before (t_0) and after (T_e) aging. Error bars indicate the standard deviation within each replica ($N=36$). A1 = Aging Replica 1, A2 = Aging Replica 2

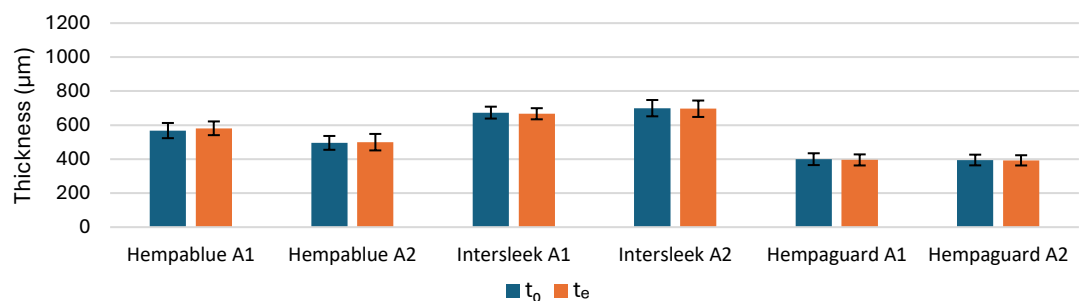
Coating thickness was measured before and after aging. For the FRCs, Hempaguard had the lowest thickness (Figure 24). Hempablue and Intersleek had comparable levels of thickness. After 10 weeks of aging, no clear effect was observed on the thickness.

Figure 24: Thickness values (μm) of FRCs before (t_0) and after (T_e) aging. Error bars indicate the standard deviation within each replica ($N=36$). A1 = Aging Replica 1, A2 = Aging Replica 2

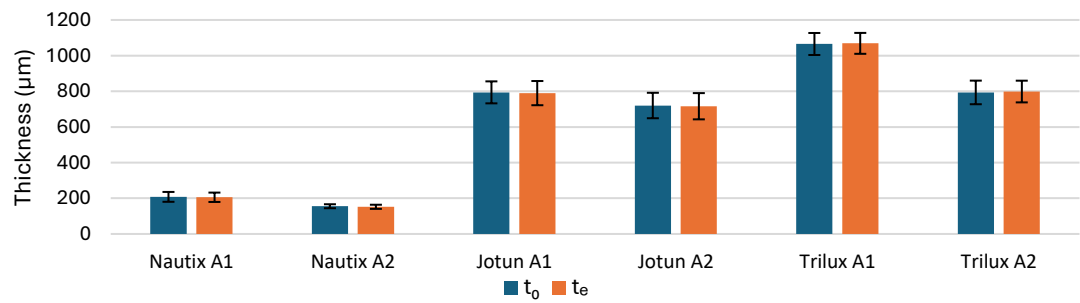
For the SPC coatings, Nautix had the lowest thickness while replica Trilux A1 had the highest thickness (Figure 25). Trilux had the largest difference between the two replicas. Dynamic aging for 10 weeks did not measurably affect the coating thickness.

Figure 25: Thickness values (μm) of SPC coatings before (t_0) and after (t_e) aging. Error bars indicate the standard deviation within each replica (N=36). A1 = Aging Replica 1, A2 = Aging Replica 2

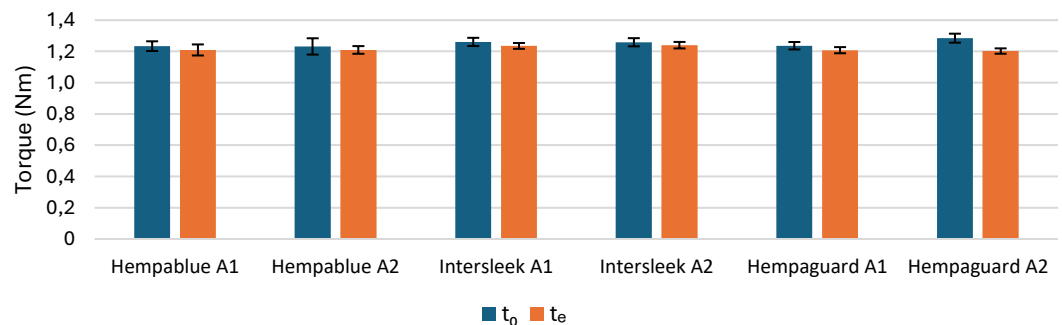
The twelve coated discs were spun on the friction disc machine to measure torque over a range of RPM speeds (500 RPM – 1500 RPM). Measurements were done before and after aging for 10 weeks. FDM values (averaged over all RPM values) between t_0 and t_e (Figure 26) did not appear different from each other. Hempaguard A2 displayed a slight decrease in torque values after aging, but this is not the case for Hempaguard A1.

Figure 26: FDM torque values of FRCs before (t_0) and after (t_e) aging. Values from the different RPM values were averaged. Error bars indicate the average standard deviation across all RPM values. A = Aging, 1 and 2 denote replicas.

During the dynamic tests (FDM), no difference in the torque values were observed before and after aging for 10 weeks (Figure 26). After exposure of the Hempablue discs on the raft for 12 weeks, only biofilm was able to establish on the coatings. Release of biofilm during the dynamic tests was observed (Plate 1) which is also reflected in the FDM torque values (Figure 33). During the first run, a ~7% increase in torque was seen while during the second run, the remaining biofilm accounted for a lower torque percentage increase of 2%-3%.

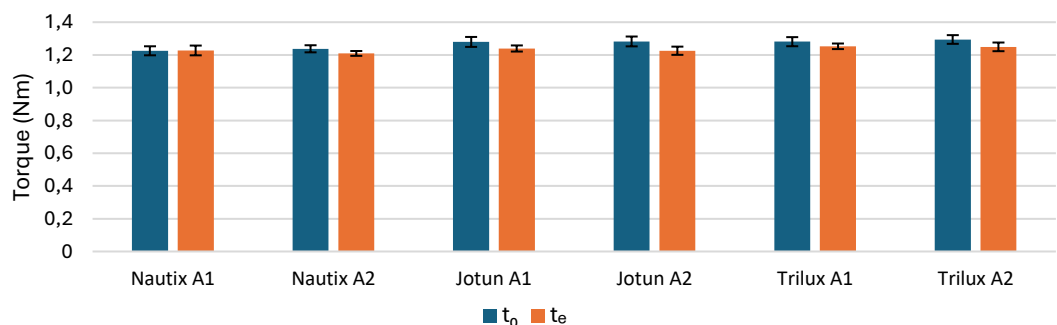
For the SPC coatings, torque values were relatively similar to the FRCs (Figure 27). A slight decrease in torque values after aging was seen for Jotun and Trilux.

Figure 27: FDM torque values of SPC coatings before (t_0) and after (t_e) aging. Values from the different RPM values were averaged. Error bars indicate the average standard deviation across all RPM values. A1 = Aging Replica 1, 2 = Aging Replica 2

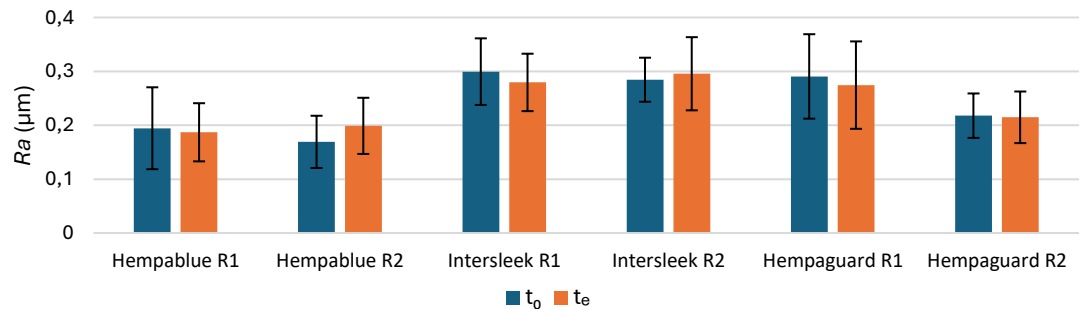
Average surface roughness (R_a) of the coatings was measured before and after exposure on the raft. FRCs had lowered R_a values (average of 0,243 μm and 0,242 μm for t_0 and t_e respectively) (Figure 29) compared to the SPC coatings (average of 1,21 μm and 1,15 μm) (Figure 30). For FRCs, R_a values did not change considerable after raft exposure.

Figure 29: Roughness values (R_a) of FRCs before (t_0) and after (t_e) raft exposure. Error bars indicate the standard deviation within each replica ($N=36$). R1 = Raft Replica 1, R2 = Raft Replica 2

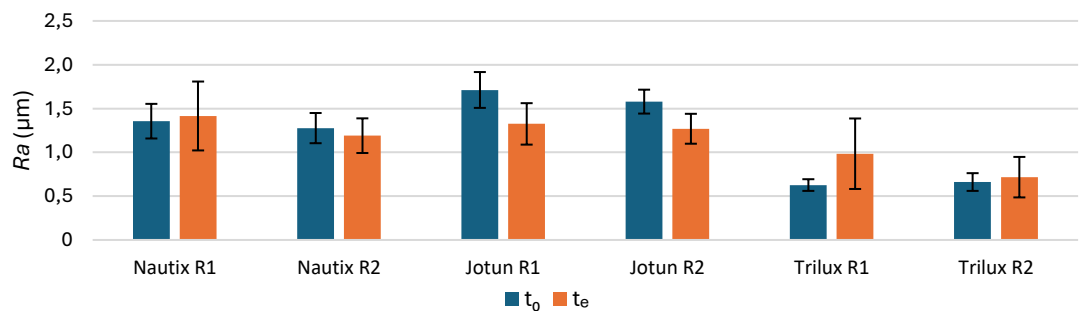
For the SPC coatings (Figure 30), average R_a values varied slightly before and after raft exposure, although always within the standard deviation. Jotun displayed slightly lowered R_a values after exposure for both replicas while Trilux R1 had a slightly higher surface roughness after exposure.

Figure 30: Roughness values (R_a) of SPC coatings before (t_0) and after (t_e) raft exposure. Error bars indicate the standard deviation within each replica ($N=36$). R1 = Raft Replica 1, R2 = Raft Replica 2

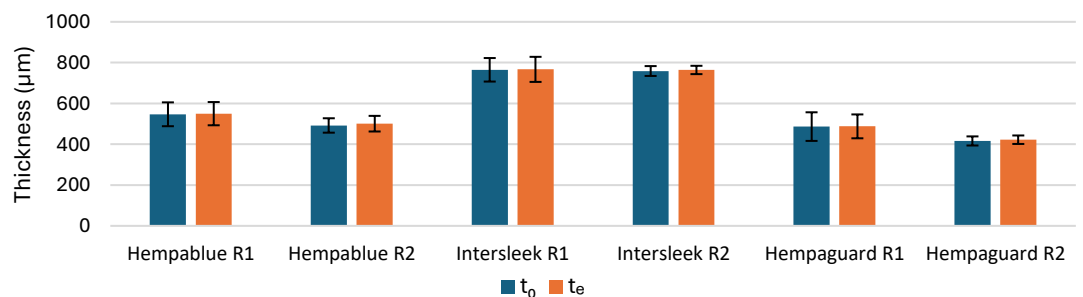
Coating thickness of the discs was measured before and after exposure of the coatings on the raft (Figure 31 and Figure 32). Exposure on the raft for 12 weeks did not alter coating thickness to a measurable degree in all FRC and SPC coatings. FRCs had slightly lower thickness than SPC coatings, except for both replicas of Nautix, which had the thinnest coating application.

Figure 31: Thickness values (μm) of FRCs before (t_0) and after (t_e) raft exposure. Error bars indicate the standard deviation within each replica ($N=36$). R1 = Raft Replica 1, R2 = Raft Replica 2

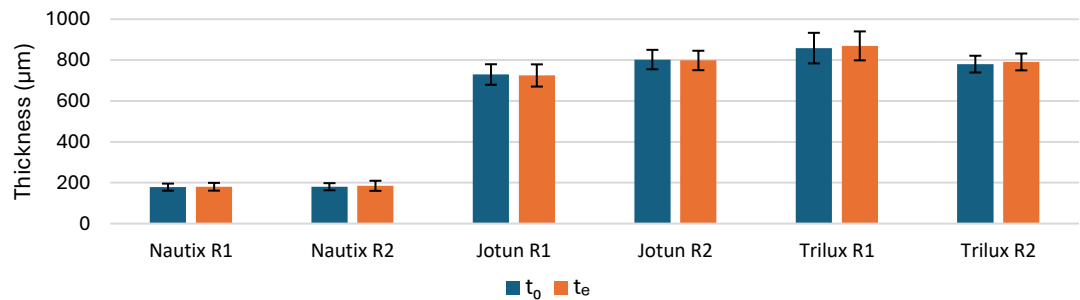
Figure 32: Thickness values (μm) of SPC coatings before (t_0) and after (t_e) raft exposure. Error bars indicate the standard deviation within each replica ($N=36$). R1 = Raft Replica 1, R2 = Raft Replica 2

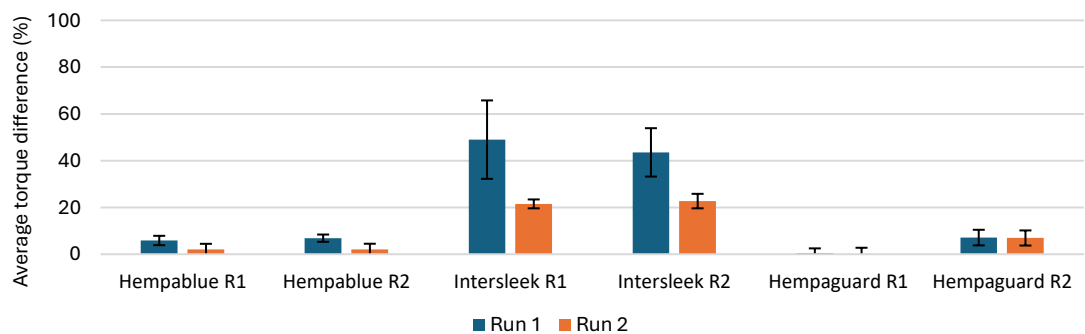
Torque values after raft exposure were obtained for all coated discs (Figure 33). These values were compared with the data after aging. **On average, the FRCs displayed lower effects of growth on torque after raft exposure compared to the SPC coatings.** Considering the FRCs, an increase in 5,8% – 6,9% in torque was observed for Hempablue R1 and R2 respectively during run 1. The remaining fouling during run 2 had negligible effects on torque for both replicas. For Hempaguard R1, effects of growth on torque after raft exposure were minimal. For Hempaguard R2, an increase in torque is observed due to the growth during exposure, which was not released during spinning, resulting in a torque increase of ~7%.

Intersleek was the only FRC that had a thick biofilm, resulting in an average increase in torque when comparing the aging vs the raft discs. This difference ranged from 50,2% to 44,6% for Intersleek R1 and R2, respectively. After run 2, an increase of torque of 22,8% and 23,8% was observed due to the remaining biofilm growth for Intersleek R1 and R2 respectively.

Figure 33: Average difference (%) in torque of FRCs between run 1 and 2 after raft exposure compared with values after aging. The different RPM data are averaged and denoted as error bars. R1 = Raft Replica 1, R2 = Raft Replica 2

During the FDM runs, Intersleek was able to release most of the heavy biofilm, but a layer of thin biofilm was left (Plate 1). The thick biofilm resulted in a torque increase around 50% compared to values after aging, while the thin biofilm was still able to increase the torque by ~23% (Figure 33). Both Intersleek discs had growth of tubeworms which, like the exposed panels, were only seen on the Intersleek coating. Intersleek R2 was not able to dislodge the attached tubeworm. However, the effect on torque of this tubeworm was not seen in the FDM data. This may be because of the positioning on the disc which is close to the centre. The closer the fouling is to the centre of the discs on the FDM, the lower the rotational force, which would lower the impact on torque of these areas.

After exposure of the Hempaguard discs on the raft, only biofilm was able to grow. The effect of this biofilm growth on the torque was negligible for Hempaguard R1 (Figure 33), indicating a higher potential to limit biofilm growth compared to Hempablue. This was also observed during T1-T4 on the exposed Hempaguard panels on the raft, where they had the lowest biofilm coverage out of all coatings. FDM values of the Hempaguard R2 disc displayed a slightly higher effect on torque than Hempaguard R1 (Figure 33). This torque increase of ~7% did not change between run 1 and run 2, indicating that the biofilm growth which increased the torque did not get released during the first run. However, there may have been an inaccuracy during the FDM measurement of the Hempaguard R2 disc. While the performance of Hempaguard is similar to that of Hempablue, Hempaguard uses a biocide in the form of copper pyrithione, which may be a point of legislation and regulation in the future. Hempablue is free of any biocides and may be a more environmentally friendly option.

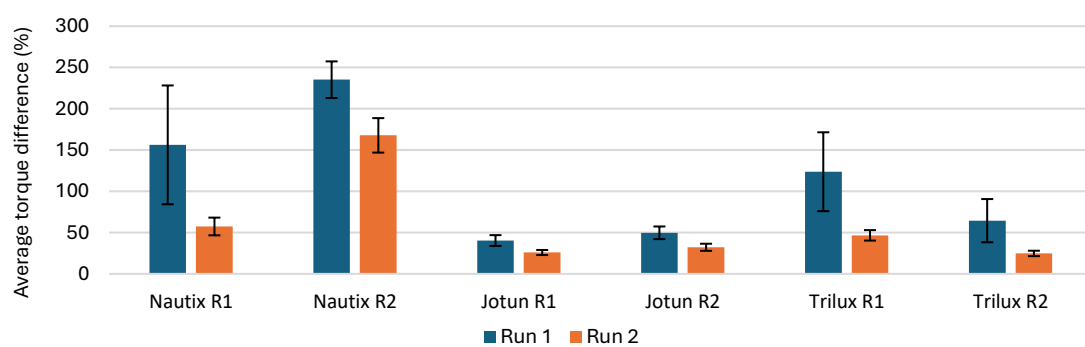
Increases in torque for the SPC coatings ranged from 40,4% to 235,2% for run 1 and between 24,8% and 167,8% for run 2 (Figure 34). Nautix had the highest increases in torque due to attached growth. After spinning, part of growth on Nautix R1 was dislodged which was not observed for Nautix R2.

Jotun had the lowest torque increase out of all the SPC coatings and some of the attached fouling was released during run 1 (from 40,3% to 25,9% for Jotun R1, and from 49,7% to 32,2% for Jotun R2).

Figure 34: Average difference (%) in torque of SPC coatings between run 1 and 2 after raft exposure compared with values after aging. The different RPM data are averaged and denoted as error bars. R1 = Raft Replica 1, R2 = Raft Replica 2

After 12 weeks of exposure on the raft, the Nautix discs were fouled with biofilm, barnacles, tunicates, and algae (Plate 1). This resulted in a high impact on the torque values (Figure 34), up to a 236% increase compared to after aging. This was the highest impact of growth on torque for any of the coatings. After the first FDM run, the Nautix replicas displayed different effects on torque, where the second run for Nautix R1 had a much lower impact on torque compared to the first run. Nautix R2 did not show this same dynamic, and instead maintained a relatively high effect on torque during run 2 of the FDM. This can be explained by the varying levels of barnacles on the two discs. For both replicas, the barnacles were difficult to release from the discs, however the initial barnacle coverage was lower for Nautix R1 than for R2, which resulted in a higher effect of the remaining barnacles on the torque by Nautix R2 compared to Nautix R1 (Plate 1).
